RCRA Compliance Evaluation Inspection Summary

SAFETY KLEEN, INC.

2549 N. New York
Wichita, Kansas 67219

Inspection Date: June 12 & 13, 2002

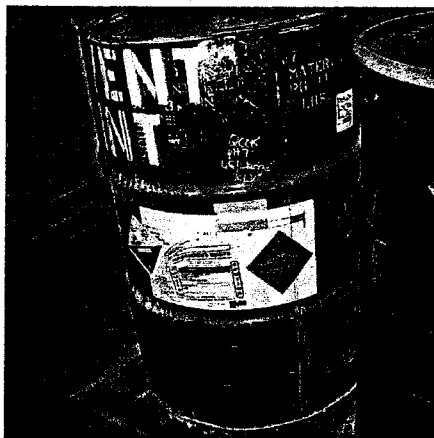
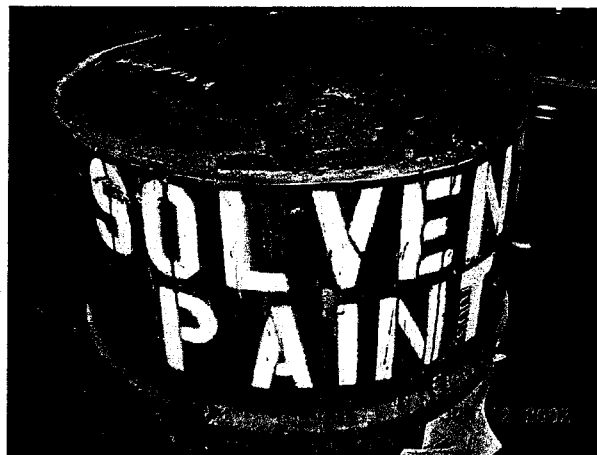
Building C is divided into seven container management units. The materials managed in these seven units include ignitable and non-ignitable hazardous waste. We observed a bulging lid on a black 55-gallon drum (D#020523-CATAL-001). The drum contains hazardous paint solvent. Refer to the attachments for the Material Profile on this waste. Refer to photographs # 10 and 11. Violation 3: Permit Condition III.C / 40CFR264.171 was cited for one storage drum not in good condition. This violation was corrected on 6/12/02. Refer to photograph # 12. The black drum was over packed into a yellow drum.

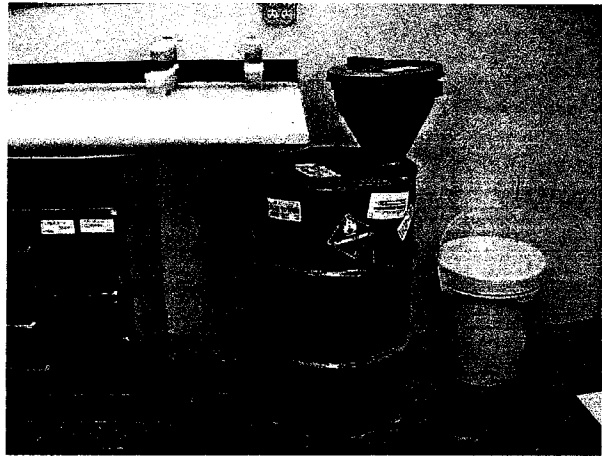
each waste material shipped to this site. We observed one 500-ml day container inside the fume hood and one 5-gallon day step can container in the lab. These containers are emptied daily into the satellite drums in the processing area. We observed one open black 30-gallon satellite drum containing hazardous liquid lab waste. Refer to photographs # 13 and 14. Violation 1: K.A.R. 28-31-4(j)(1)(A), was cited for an open satellite drum of hazardous waste. This violation was corrected on 6/12/02. Refer to photograph # 15.

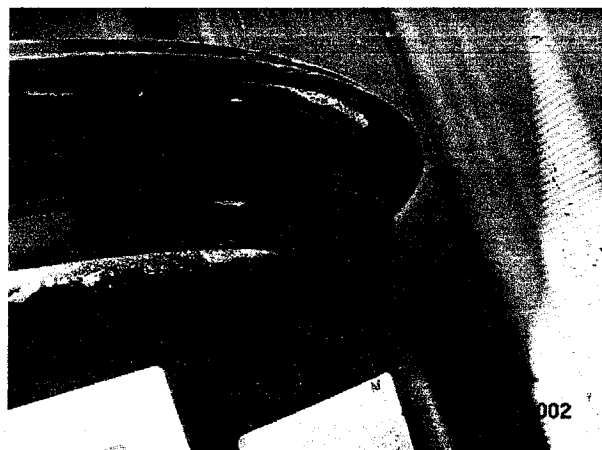
Photograph 16

The processing area is divided into two container management units. The materials managed in both units are liquid and solid hazardous waste. The processing area is where containers are logged into the facility's computer and labels are generated. Laboratory sampling is conducted in this area. We observed one open black 55-gallon satellite drum containing personal protective equipment (PPE). Refer to photographs # 16 and 17. Violation 1: K.A.R. 28-31-4(j)(1)(A), was cited for one open satellite drum of hazardous PPE waste. This violation was corrected on 6/12/02.

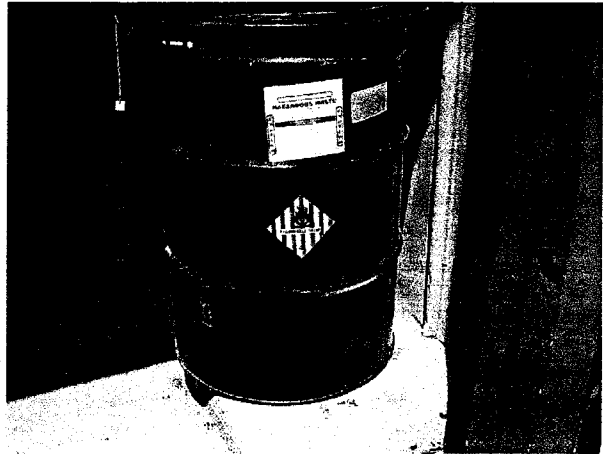
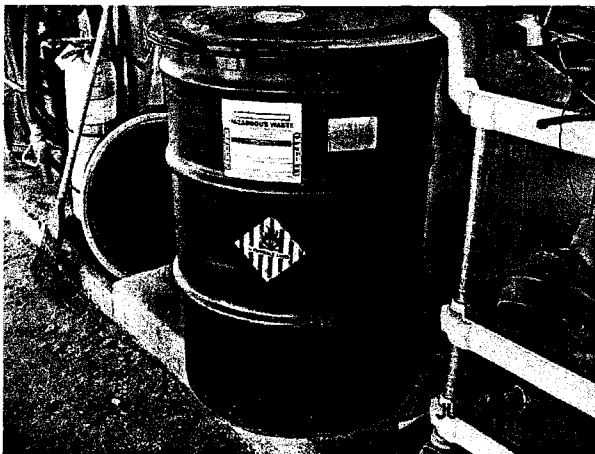
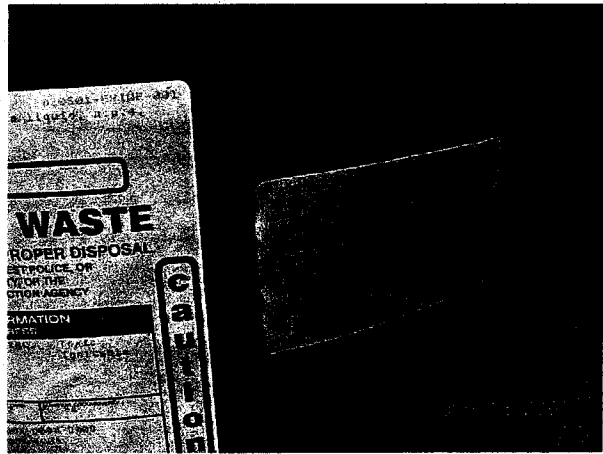
We observed two black 55-gallon satellite drums containing PPE waste. The date marked on the drums was 5/1/02. This was the date that the facility started filling the drums. Refer to photographs # 17 through 19. Violation 5: K.A.R. 28-31-4(j)(2) was cited for an improper start accumulation date on two 55-gallon satellite drums. This violation was corrected on 6/12/02. Refer to photographs # 20 and 21.
